# Manhole Inspection Summary

Manhole # S25I\_\_028MH

Insp Date: **1/14/09 9:20 AM**

**Location** Address: **1120 W LOMBARD ST**

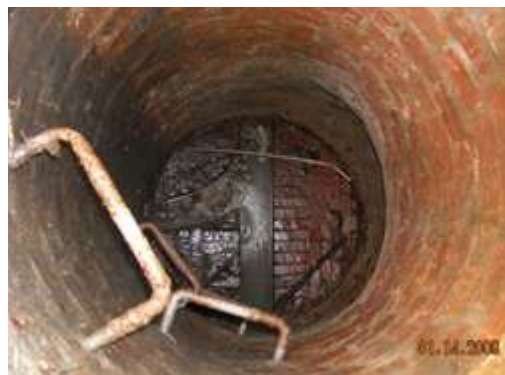
Top View

**Channel** Material: **Brick** ☐ Parged  
Channel Exposure: **Fully Open** Junc Dist: **0** nearest .5 ft. Azimuth: **0**  
Condition: ☐ Sound ☐ Cracked ☐ Root Intrusion ☐ Deteriorated ☐ Leaks ☒ **Debris**

**Steps** Count: **6** Missing: **0** ☒ **Corroded**
